# Manhole Inspection Summary

Manhole # S49CC\_005MH

**Inspection** ☐ Is Incomplete Rating: **3) Fair**

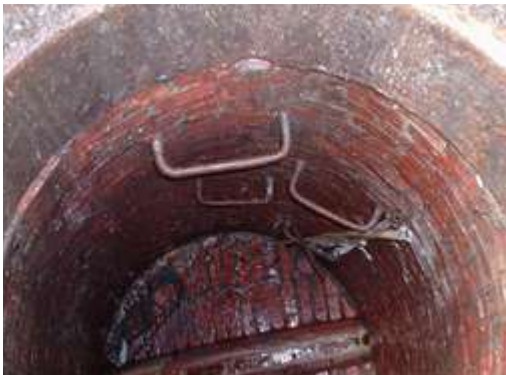
Defect 1

☒ **Leaks**

Adjustment Frame

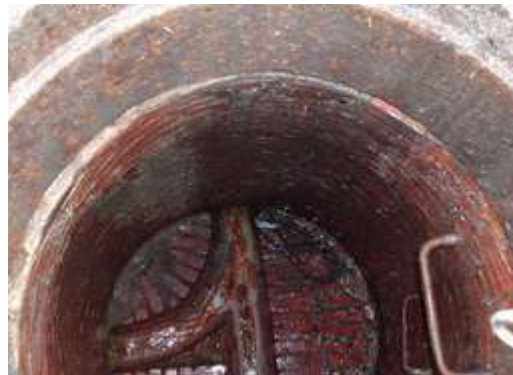
Defect 2

Infiltration: ☐ None ☐ Joint ☐ Cracks ☐ Mortar ☐ Roots ☒ **Wall**

Adjustment Joints

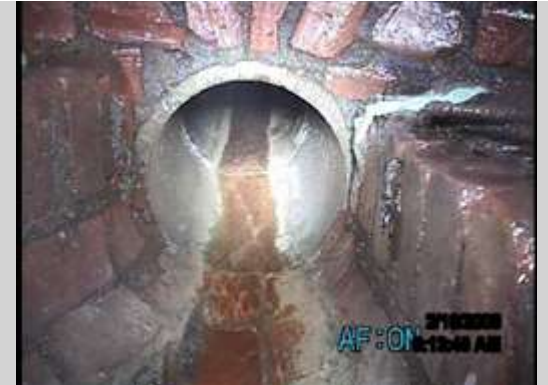
12 O'Clock Outflow

10 in. Circular Gravity Sewer  
Pipe Out @ 12 O'Clock

Pipe Height: **10.8** (in.) Rod and Bar (Angled)  
Pipe Material: **Clay** ☐ Pipe Lined  
Invert Depth: **9.00** (ft.) Flow Characteristics: **Slow**  
Deposits: ☒ None ☐ Mud ☐ Sludge ☐ Debris ☐ Grease  
Silt Depth: (in.) Deposits Extent:  
Infiltration: **None** Pipe Seal Cond: **Sound**

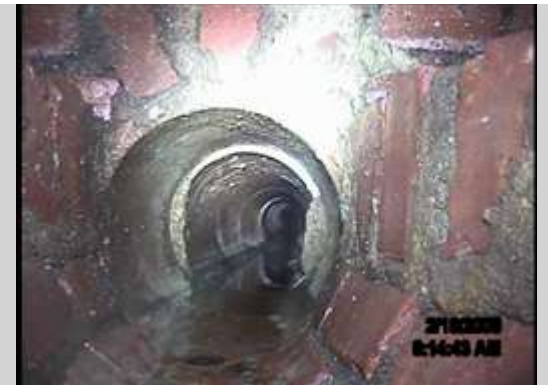
6 O'Clock Inflow

10 in. Circular Gravity Sewer  
Pipe In @ 6 O'Clock

Pipe Height: **9.6** (in.) Rod and Bar (Angled)  
Pipe Material: **Clay** ☐ Pipe Lined  
Invert Depth: **8.48** (ft.) Flow Characteristics: **Slow**  
Deposits: ☒ None ☐ Mud ☐ Sludge ☐ Debris ☐ Grease  
Silt Depth: (in.) Deposits Extent:  
Infiltration: **None** Pipe Seal Cond: **Sound**

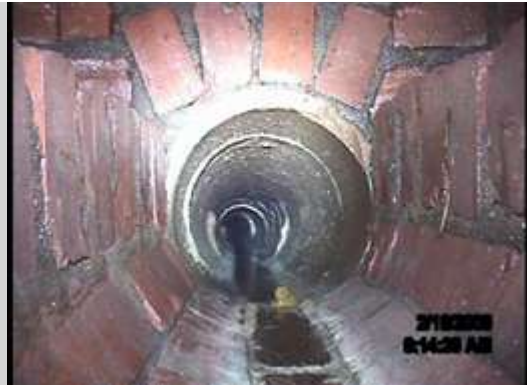
9 O'Clock Inflow

10 in. Circular Gravity Sewer

Pipe In @ 9 O'Clock

Infiltration: **None** Pipe Seal Cond: **Sound**
